A Technological History of Municipally Owned  
Public Transportation in Edmonton, 1893-1981

A THESIS

SUBMITTED TO THE FACULTY OF GRADUATE STUDIES AND RESEARCH  
IN PARTIAL FULFILLMENT OF THE REQUIREMENTS FOR THE DEGREE  
Master of Education in Industrial Arts Education

VOLUME II

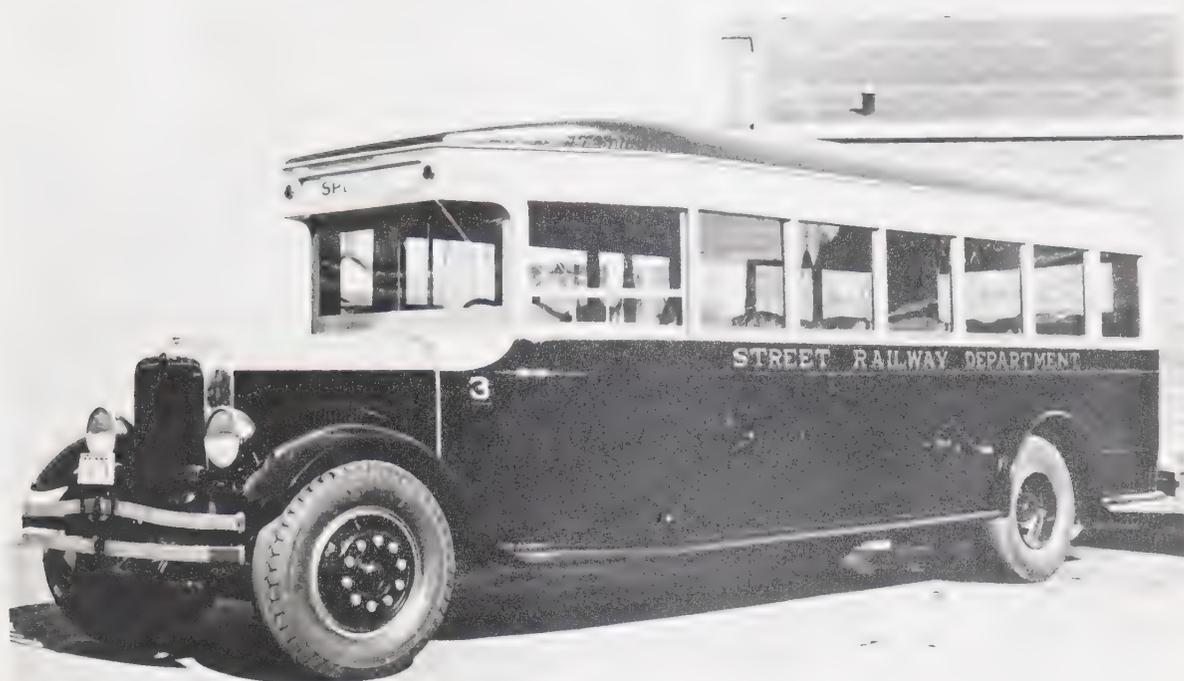
Plate 34. (Glenbow Archives) Bus Number 3 in 1932

The body was painted in the same manner as buses Numbers 1 and 2. This unit was numbered "3". Plate 34 (Glenbow Archives) shows the external appearance of bus Number 3 at the Fane Auto Works upon its completion in April 1932. Plate 35 (Glenbow Archives) shows the interior view of the bus at this time. The photographer was standing near the front of the body and was facing the rear of the bus. The leather upholstered seats as well as the handrails should be noted.

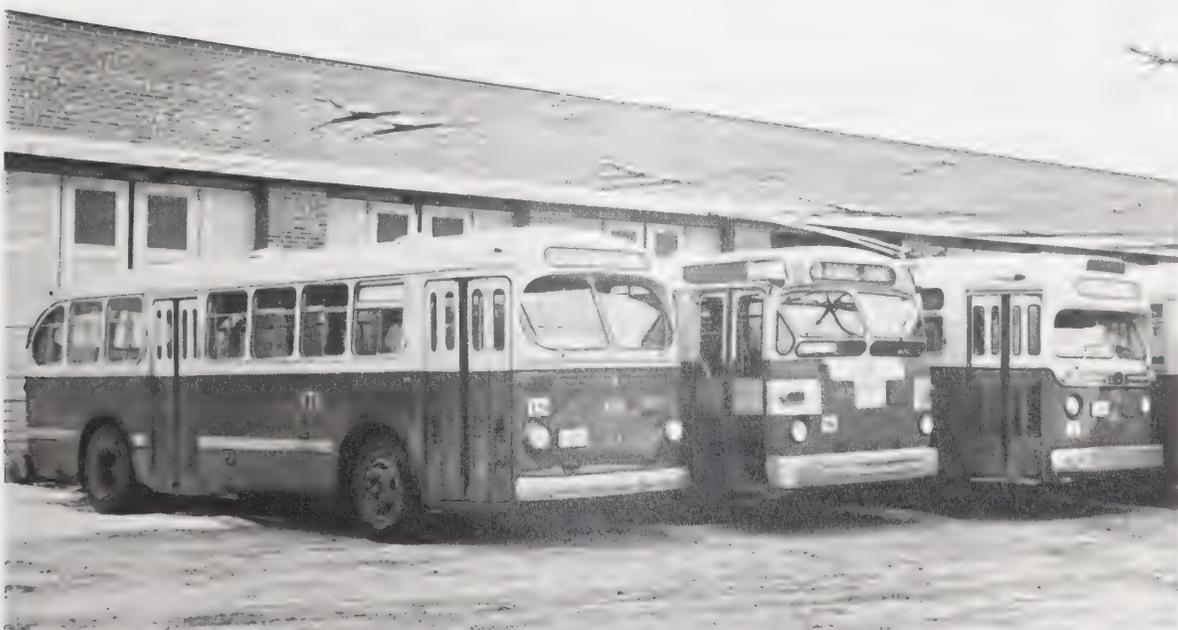
Plate 37. (Provincial Archives of Alberta) Buses at Strathcona Garage in February 1958

to the ETS from Canadian Car and Foundry Co.) Plate 37 (Provincial Archives of Alberta) shows the appearance of bus Number 33 in February 1958. The decalcomania monograms should be noted. It should also be realized that the storm sashes on the side windows were obtained after the buses had been in service for some time.

the C-36 motorbuses. (See Plates 37 and 44)

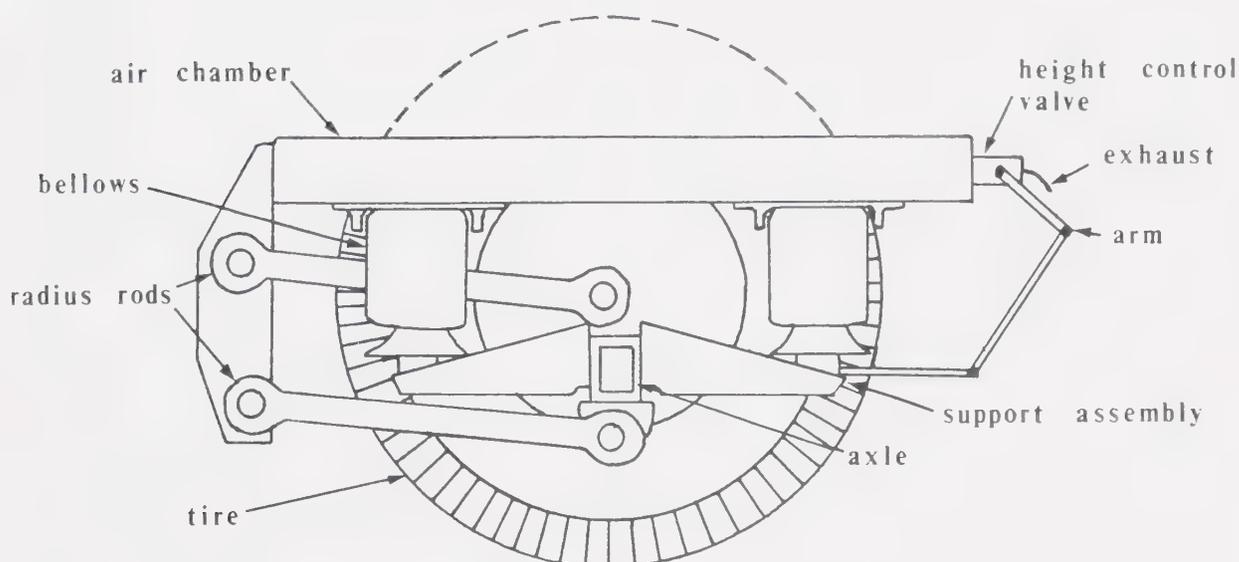
**FIGURE 39. GENERAL LAYOUT OF AIR SUSPENSION**

tions in the road from affecting the air suspension. Since rubber bellows were not strong enough to hold the axles in position, steel radius rods with neoprene bushings prevented the axles from moving out of position. (Canadian Transportation, November 1953, pp. 651-652, and GMC Maintenance Manual, 1962, pp. 291-297)

Figure 39 (after Drawing in GMC Maintenance Manual, 1962, p. 291) shows the basic apparatus and the layout of the GMC air suspension system. It should be noted that the system was easy to maintain since no parts required lubrication and the only items that were designed to be replaced periodically were the bellows and the shock absorbers.

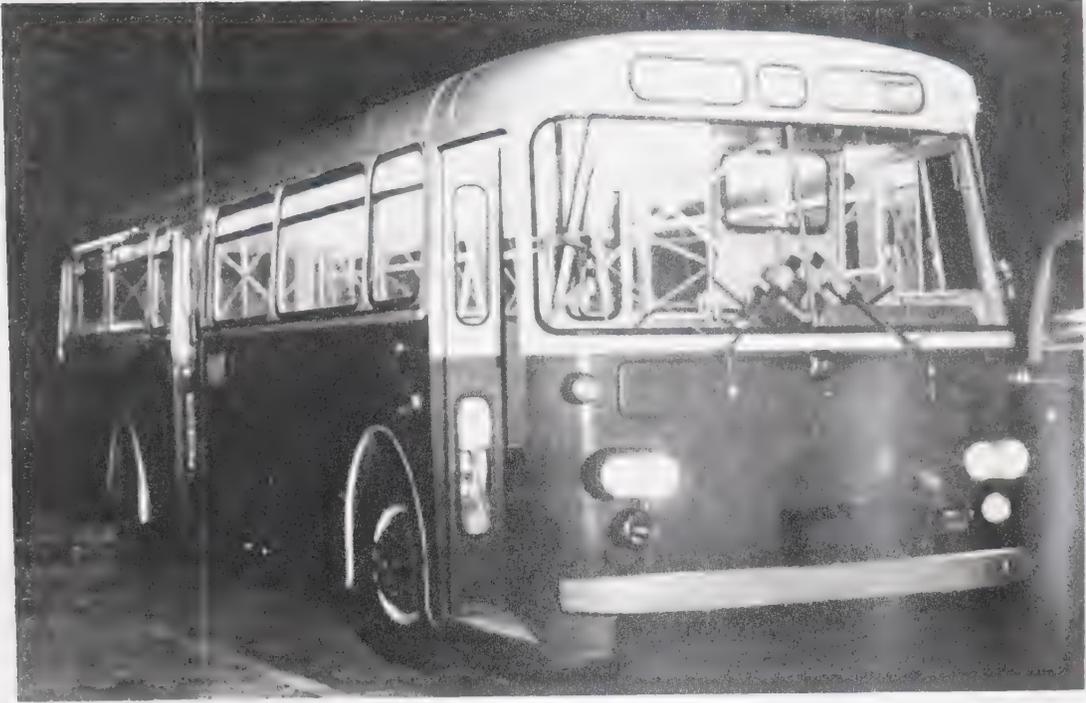
Plate 38. (City of Edmonton Archives) A Nissan Bus at the Time of Delivery in 1964

located directly beneath the headlights. (Specifications of Nissan Diesel Bus, p. 14, and Plate 38)

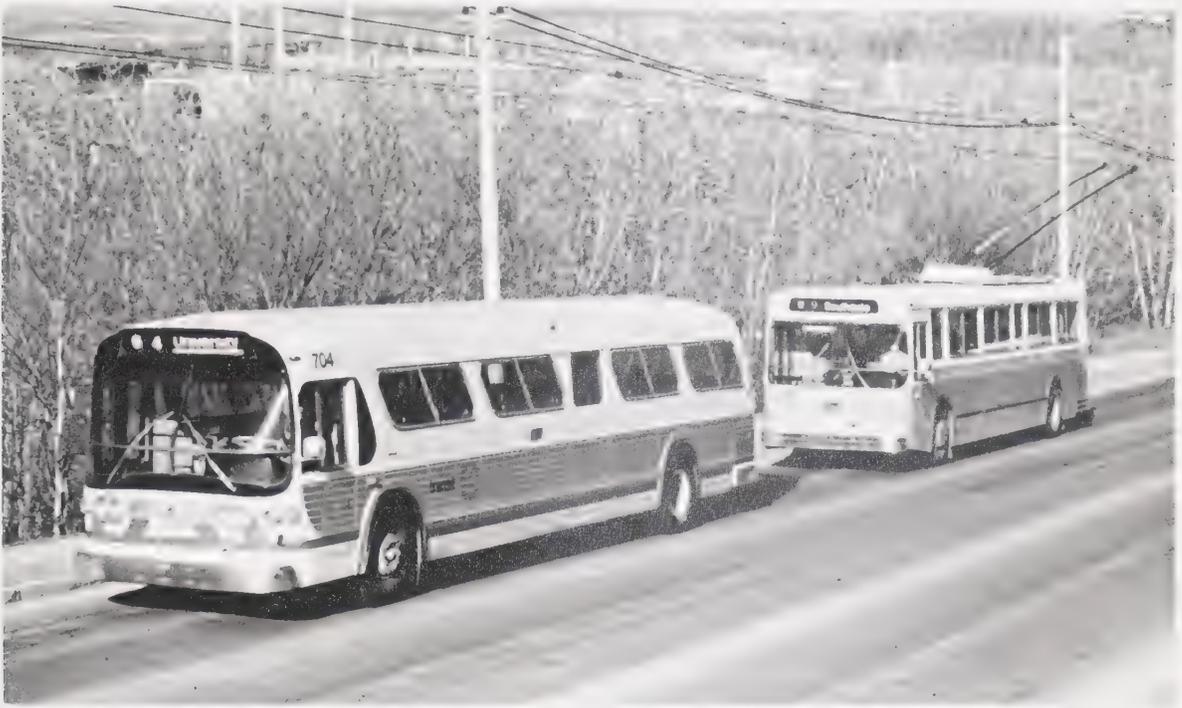
Plate 40. (Author's Photograph) Bus Number 704 (2nd)  
Trolley Bus Number 247

During 1976 and 1977, ET ordered an additional 70 GMC T6H-5307N buses, as well as 18 Flyer Industries model D10240 buses. The GMC buses were identical to the previous order and were numbered 698 through 767. (See Appendix I) Plate 40 (Author's Photograph) depicts bus Number 704 during 1978. The new ET paint scheme as well as the lack of standee windows should be noted.

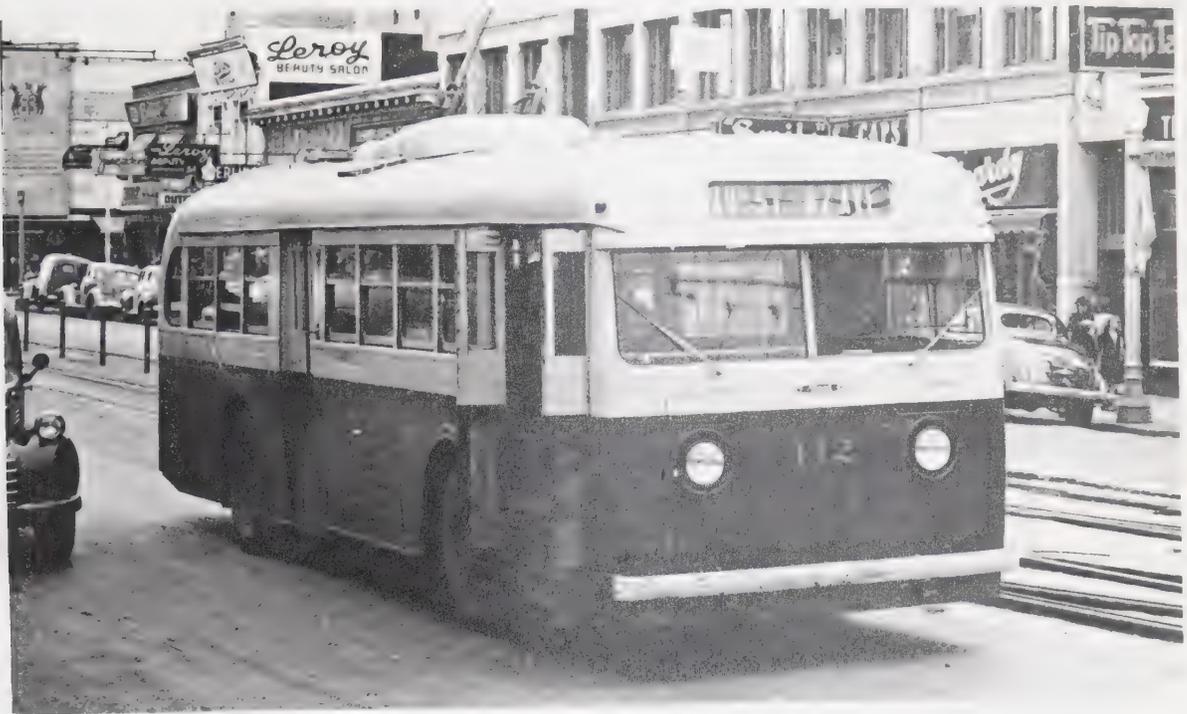
Plate 42. (Glenbow Archives) Trolley Bus Number 112 in 1943

Each bus was painted in the SRD colors but without the orange band and the black stripes. This paint scheme, therefore, moved the ivory areas below the bottoms of the windows. Each bus was numbered on the front and the rear only. (Mack Photographs CR-1277-143V6203 to CR-1277-143V6206) The trolley buses were numbered 110 through 112 and were shipped to Edmonton late in January 1943 and arrived in Edmonton during February. (Telegram to Commissioner R. J. Gibb from Mack Manufacturing Co., January 26, 1943) Plate 42 (Glenbow Archives) shows trolley bus Number 112 on Jasper Avenue during 1943. The different body shape as compared to the AEC-EE trolley bus in Plate 41,

as well as the single rear axle, vertical windshield wipers, the lack of a steel framework for the trolley bases and the plain paint scheme should be noted.

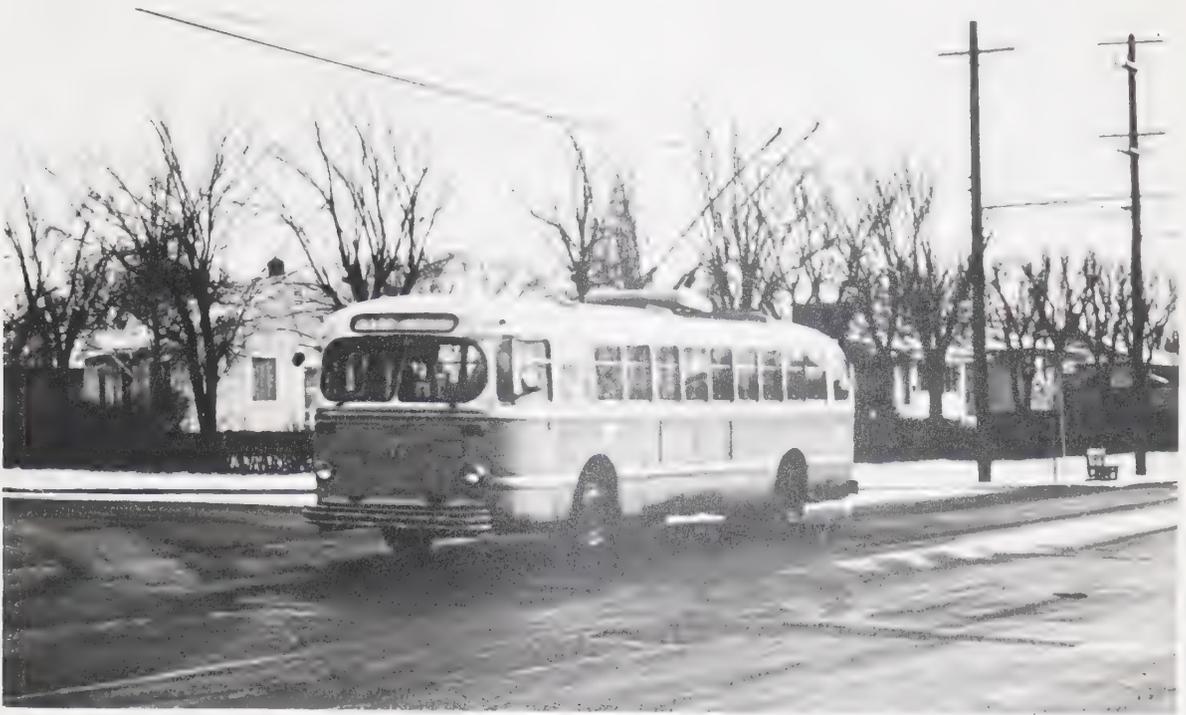
Plate 44. (Author's Photograph) Trolley Bus Number 195

It was mentioned in the previous Chapter that the ETS introduced the use of fibreglass replacement panels on their buses during 1954. The use of such panels was also extended to the trolley bus fleet. (Edmonton Journal, October 18, 1954, p. 21) The use of fibreglass panels was facilitated on the model T-44 and T-48A trolley buses since their body panels were the same, in most instances, as the body panels on

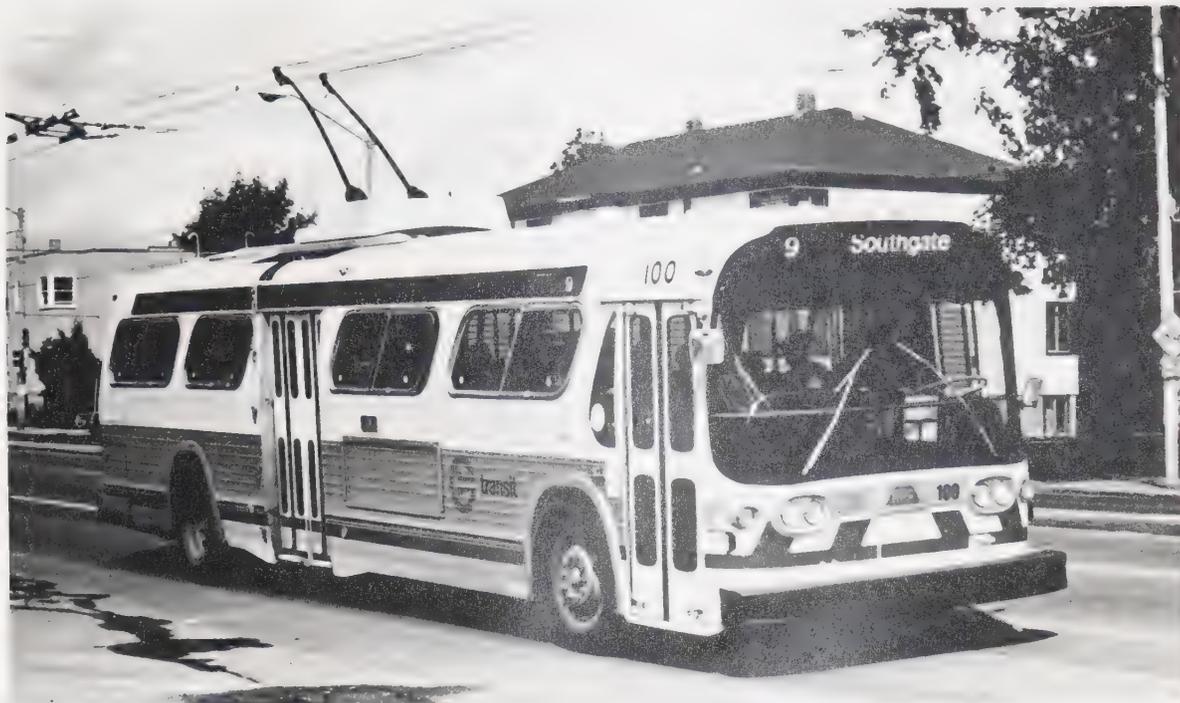
Plate 46. (Author's Photograph) Trolley Bus Number 100

The 100 Brown Boveri trolley buses were numbered 100 through 199. (See Appendix I) Number 100 arrived in Edmonton during October 1981 and was placed in service during November. The remaining units were placed in service during 1982. (ETAR, 1982, p. 30) Plate 46 (Author's Photograph) shows trolley bus Number 100 in early 1982. The standee windows as well as the steps to the roof should be noted.

The appearance of the GMC transit bus body has remained unaltered basically since 1960. Buses Numbers 434 through 438, therefore, resembled the trolley bus which is shown in Plate 47. It should be noted that the paint scheme on the trolley bus was introduced during the late 1970's and was not initially applied to buses Numbers 434 through 438. The air intake duct below the second large window should be noted.

The bodies for these trolley buses were manufactured at GMC's Quebec plant and were similar to the T6H-5307 diesel buses described in Chapter VI. Standee windows as well as operator controlled centre exit doors were provided, however. (See Plate 46) The arrangement of the seating on these trolley buses was similar to the seating arrangement on the last six T-48A trolley buses purchased by the ETS, Numbers 197 through 202. The new trolley buses, therefore, could seat only 42 passengers. It should be noted that since GMC was a subcontractor to Brown Boveri, the normal GMC insignia on the front of the bus was replaced with an insignia which contained the letters "BBC" which was short for

The power pedal was connected to a small variable resistor which controlled voltage in a circuit which was connected to the chopper's control circuits. Dynamic braking blended with air braking was provided with these trolley buses. The required rheostats as well as auxiliary heaters were located in the heating compartment on the bus which normally contained the hot water heaters on the diesel version of the model 5307 bus. (Brown Boveri Specifications, 1982) Trolley voltage was obtained from two roof mounted Ohio Brass trolley bases which were enclosed by a fibreglass cowling. (See Plate 46)
